GENUINE CUMMINS PARTS

THE GENUINE DIFFERENCE, MAGNIFIED

NON-GENUINE PUT TO THE TEST

Bulletin 6373165 Produced in U.S.A. Rev. 3/22
©2022 Cummins Inc.

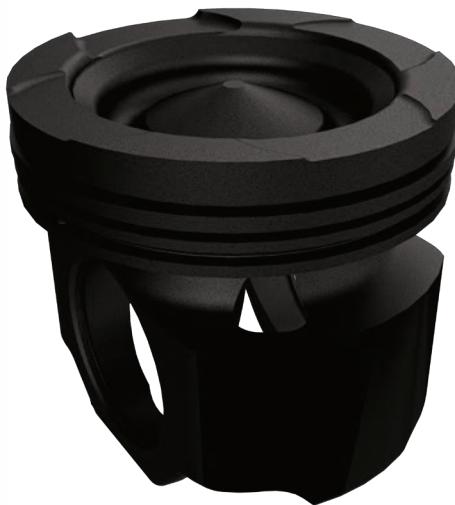
PISTONS

DIMENSIONAL TESTING: FAILED

- Utilizes the old, non-APR (Anti-Polishing Ring) design
- RISKS:** Carbon buildup on top land of the piston which can polish out cylinder liner cross-hatch

MATERIAL TESTING: FAILED

- Deficient microstructure and steel alloy content
- RISKS:** Thermal fatigue and reduced service life

Using the old, non-APR design can lead to the buildup of carbon which can polish out the cylinder liner cross-hatch, leading to increased oil consumption, blow-by, reduced power, progressive damage to the aftertreatment, and even catastrophic engine damage.

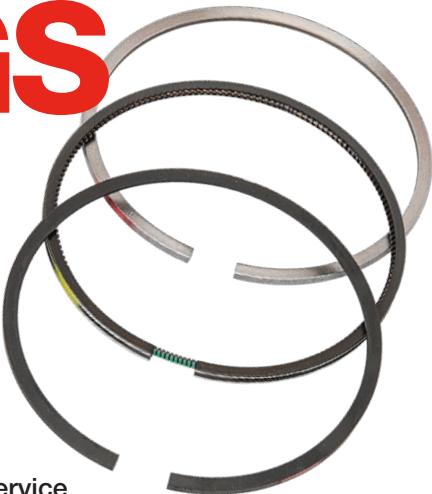
PISTON RINGS

DIMENSIONAL TESTING: FAILED

- Coating thickness below specification
- RISKS:** Delamination of coating, reducing service life; improper sealing of ring causing excessive blow-by and oil consumption

MATERIAL TESTING: FAILED

- Material hardness below specification
- RISKS:** Lower durability and robustness; reduced service life

Piston ring failures can cause severe catastrophic power cylinder damage resulting in loss of power as well as progressive damage to the cylinder head, turbo and other downstream components such as the aftertreatment.

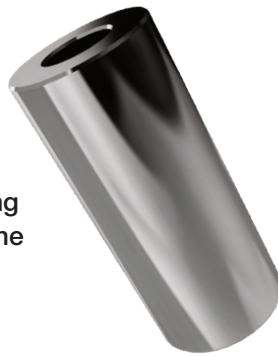
PISTON PINS

DIMENSIONAL TESTING: FAILED

- Inner and outer diameter do not meet specification
- **RISKS:** Fitment issues with mating parts

MATERIAL TESTING: FAILED

- Material does not meet specification
- **RISKS:** High potential for cracking, piston pin failure

Piston pin joint seizure can result in severe catastrophic engine failure when the connecting rod is no longer able to move freely in relation to the piston.

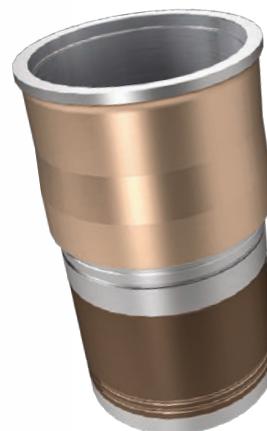
CYLINDER LINERS

DIMENSIONAL TESTING: FAILED

- Utilizes the old, non-APR (Anti-Polishing Ring) design
- **RISKS:** Assembly issues, carbon buildup
- Case depth of inner diameter is above specification
- **RISKS:** Residual strain on part; impacted performance

MATERIAL TESTING: FAILED

- Microstructure of inner diameter does not meet specification
- **RISKS:** Reduced wear resistance during engine operation

Cylinder liner failure can result in inefficient combustion, reduced power, excessive wear of related parts such as piston rings, increased oil consumption, blow-by and progressive damage to aftertreatment.

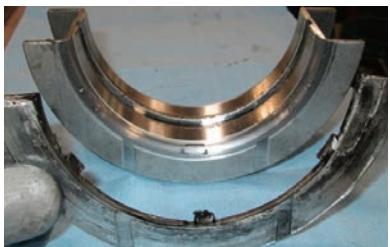
MAIN BEARINGS

DIMENSIONAL TESTING: FAILED

- Missing critical oiling grooves

• RISKS: Improper oiling to bearing; potential for thrust bearing failure

MATERIAL TESTING: FAILED

- Does not meet specification for material requirements or lining thickness

• RISKS: Robustness of material is severely compromised; high potential for delamination

Delamination of bearing layers, corrosion and the absence of critical oiling grooves can lead to spun bearings which result in severe catastrophic engine damage.

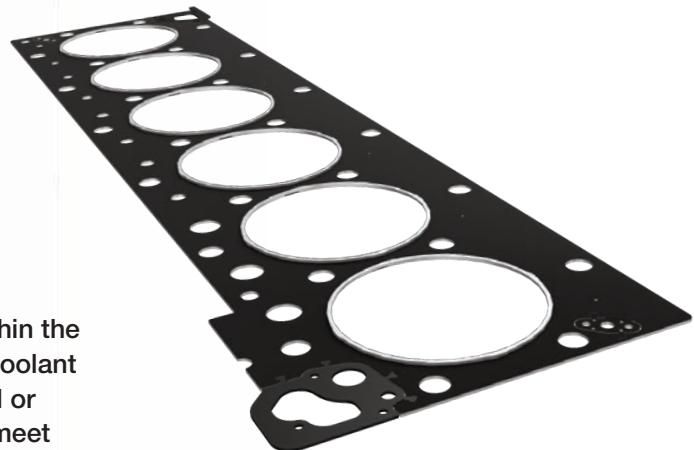
HEAD GASKETS

DIMENSIONAL TESTING: FAILED

- Fluid passage hole is incorrectly sized
- Missing fluid passage hole
- **RISKS:** Fluid flow obstruction resulting in improper coolant & oil flow; major engine damage

Fluid flow obstructions can result in major catastrophic engine damage due to inadequate cooling or oil flow restriction.

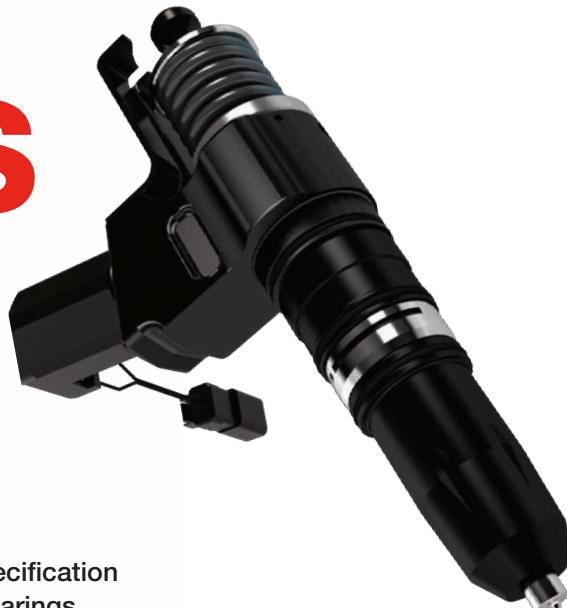
INJECTORS

IMPROPER SPRAY PATTERN

FUNCTIONAL TESTING: FAILED

- Torque from solenoid and retainer below specification
- **RISKS:** Fuel carryover to engine oil; spun bearings
- Needle valve pop-off pressure below specification
- **RISKS:** Reduced injector fuel flow; Low engine power and improper combustion
- Solenoid closing time below specification
- **RISKS:** Shortened injector life; injection timing issues
- Barrel flow above specification
- **RISKS:** Improper combustion; injection timing issues

Improper injector function can result in inefficient combustion, misfire, reduced power and progressive damage to the power cylinder or downstream components such as aftertreatment.
